ASHTON LAGOON RESTORATION PROJECT

Project Background

Status Update

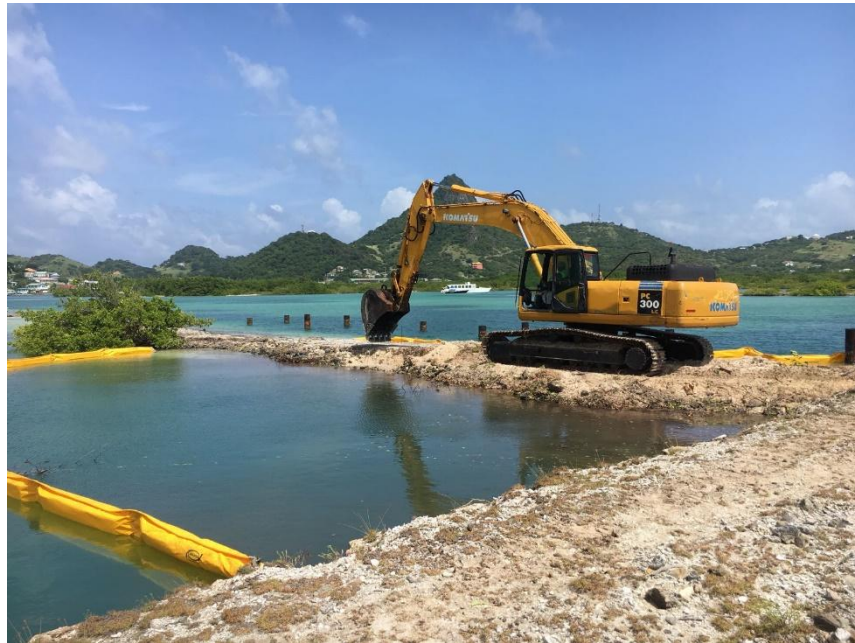
Excavator beginning work on Pier#2

4. Excavation of five 15 m wide breaches in the finger piers the marina structure (Gap 01 to Gap 05 shown in Drawings SWIL-ALUI01, SWIL-ALUI02 and SWIL-ALUI03) (see attached)
5. Grading channel edges to the required slope where required

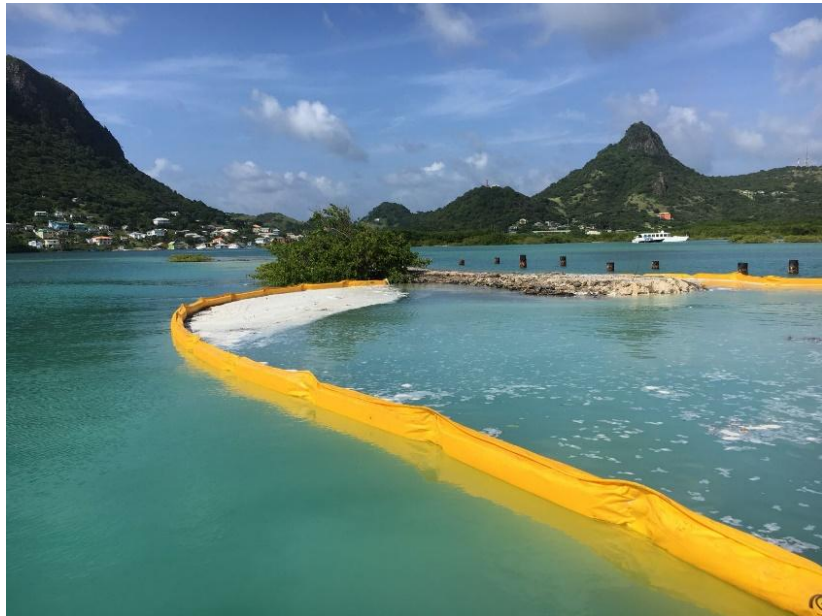
Turbidity barriers put in place for excavation.

1. Deploying turbidity barriers (otherwise known as sediment curtains) around the sites of excavation to prevent sediment from escaping;
2. Testing material that will be excavated for contamination testing to determine whether it can be safely disposed of on the project site or at a suitable site on land
3. Disposal of excavated material in a manner that causes negligible harm to the environment. The disposal method shall depend upon the results of the contaminant testing. If free from contaminants, the material is to be placed on the seaward side of the outer causeway. Boulders will be washed so as to remove sediment prior to placement. If contaminated, the material shall be disposed at a suitable site on land.

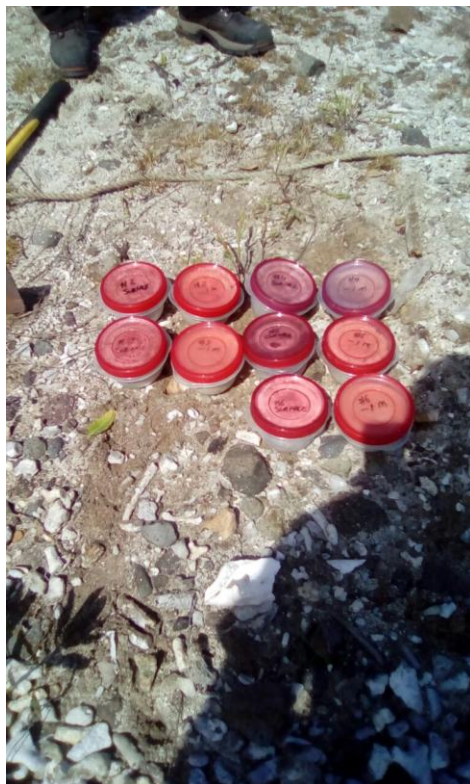
Soil samples from each finger piers
